FOR JULY 1, 1993 THROUGH OCTOBER 1, 1993

HISTORICAL RELEASE REPORT (HRR)

**ENVIRONMENTAL RESTORATION
FACILITIES OPERATIONS MANAGEMENT**

Historical Release Report (HRR)
Quarterly Report Submittal
July 1, 1993 - October 1, 1993

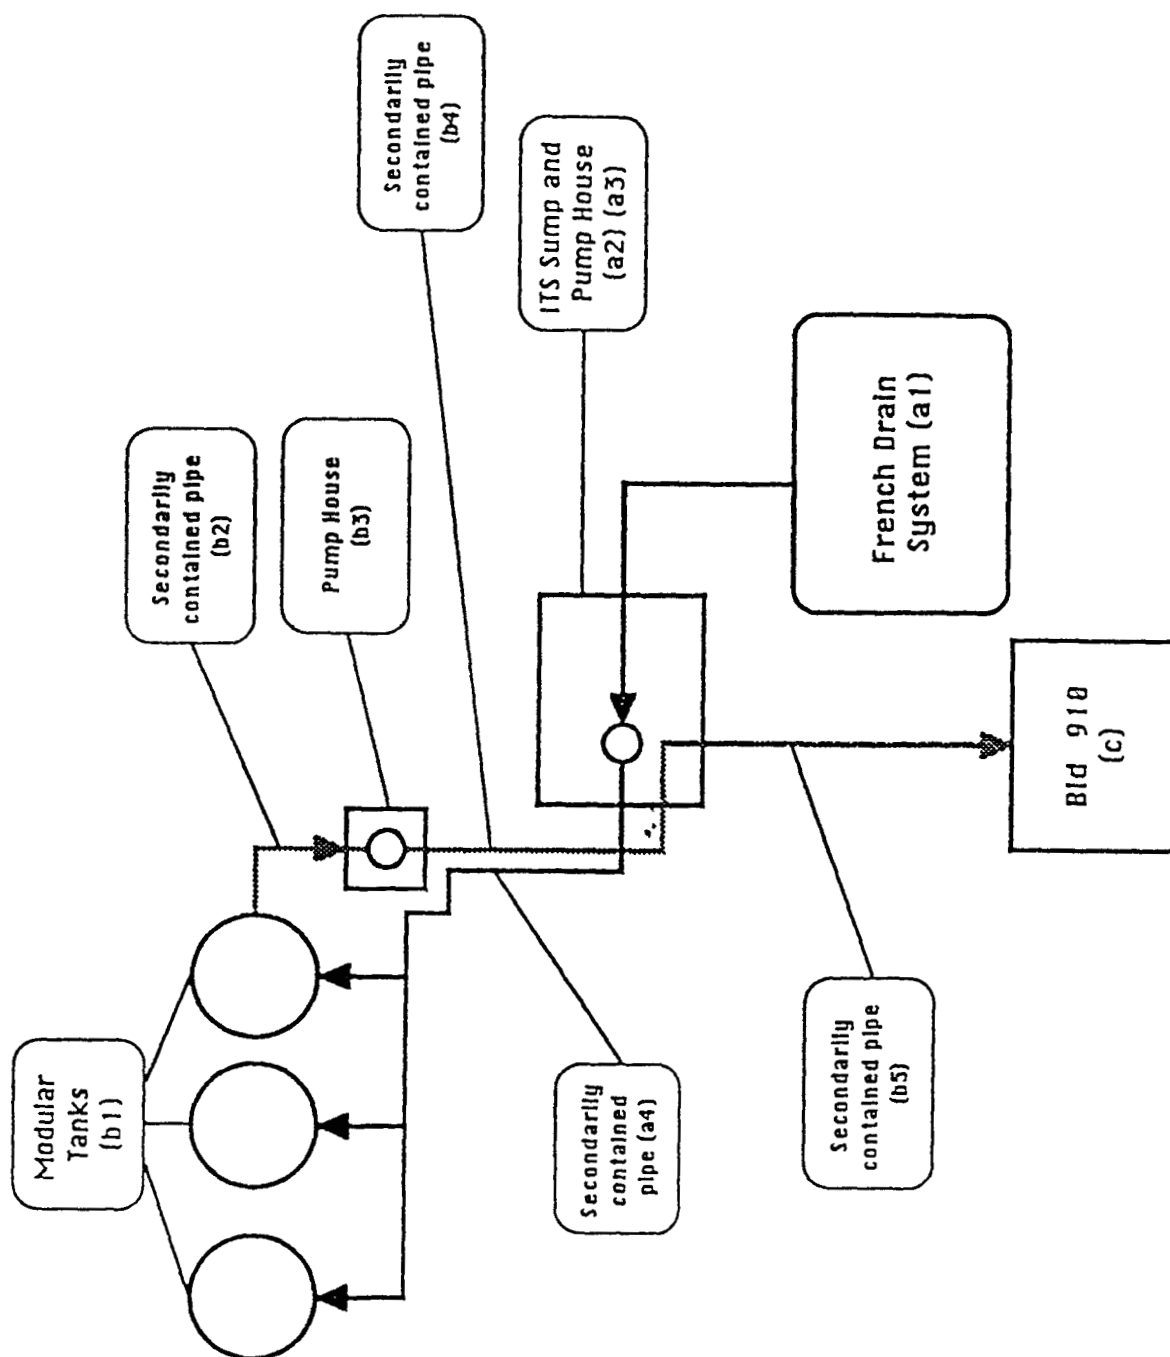
ITS System

Some of the hazardous waste also gravity-drained through a failed hose connection on the secondary containment piping (item [a2] on figure) located within the ITS sump. The ITS sump is equipped with automatic level controls which caused this spilled material to be pumped back into the modular tanks.

- 1 Repair the primary transfer pipeline
2. Modify the secondary containment of the portion of the line within the ITS sump to prevent leakage of water back into the sump. Although the portion of the line can be visually inspected, it is preferable to modify the secondary containment in this manner

- 3 Retest the line following repair.
- 4 Complete or repair the installation of leak-detectors in the secondary containment portion of the line that were not operational at the time of the incident

- 5 Confirm that the process control logic supports positive shut-down of the pumps when a leak is detected in the secondary containment system in the ITS sump.

- 6 Repair the remote alarm which was not operable when the liquid (waste) was released into the pumphouse
- 7 Analyze pressure conditions in the Building 910 feed system to determine if components experienced an over-pressurization (repair as needed)

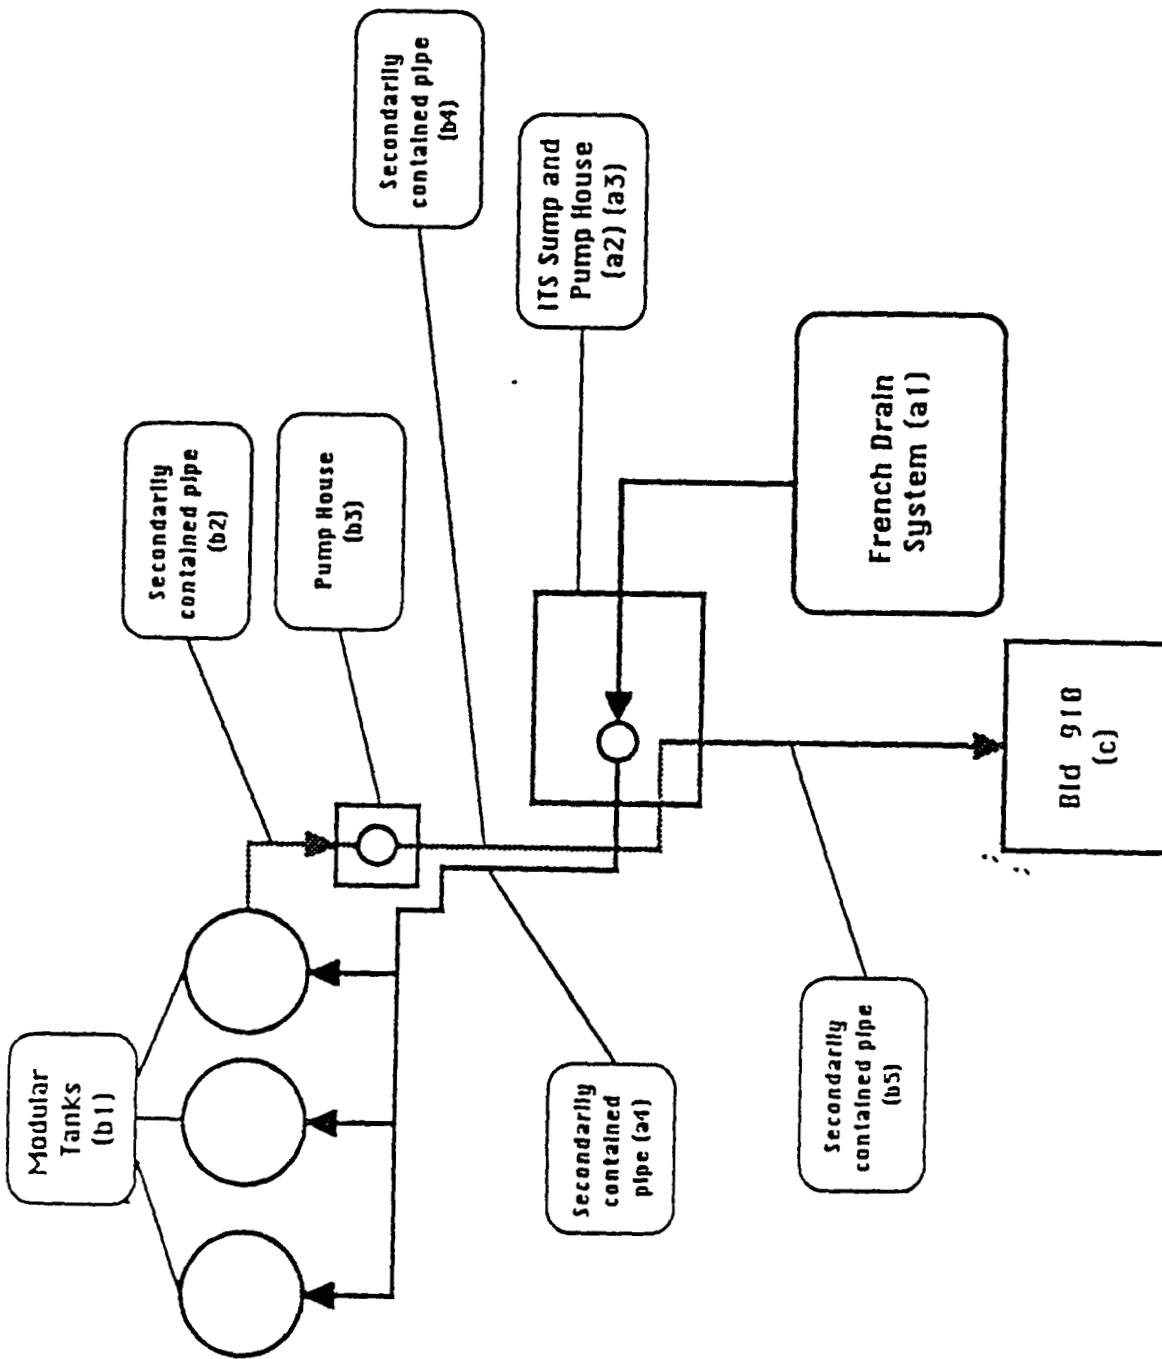
FIGURE 2

Prior to 1 00_p m on July 20, 1993, a leak occurred in the primary containment piping (reference Figure 2 - item (b4)) located between the modular tanks and the ITS sump (reference Figure 2 - item a2) which allowed waste to leak into the secondary containment. Due to the location of the leak in the pipeline, the hazardous waste that leaked into the secondary containment overflowed back into the Modular Tank pumphouse (reference Figure 2 - item b3) and also gravity-drained through a failed hose connection on the secondary containment piping (reference Figure 2 - item a2). The failed hose connection is located within the ITS sump. The ITS sump is equipped with an automatic level controls and the material that spilled into the ITS sump was pumped back into the Modular Tanks. The hazardous waste that overflowed into the Modular Tank pumphouse was fully contained in the pumphouse secondary containment. When the liquid level in the pumphouse secondary containment rose, the leak detection system was activated, the local alarm was activated, and the pumps were automatically shut down. The remote alarm via telemetry to Building 374 did not, however, function. Problems had occurred previously and this alarm was not reliable; therefore, it had not been considered operational and compensatory measures were in place to perform daily checks of the local alarm panel. This deficiency had been identified as an open item to be corrected.

- b) Hazardous waste continued to drain from the hose connection on the secondary containment into the ITS sump for several hours; the sump was checked several times after the problem was initially discovered at about 1:30 p.m. on July 20, and drainage from the secondary containment had ceased by 4:30 p.m. on July 20 when the transfer piping secondary containment drained to the low point of the line in the ITS sump. The material that drained into the sump was automatically pumped back into the Modular Tank system and was removed from the sump by 5:00 p.m. on July 20.

The released material is, however, RCRA F-listed hazardous waste. In accordance with 6 CCR 1007-3, the pumping operation at the ITS sump is considered a waste generation point (reference Figure 2 - item a3). At this point (reference Figure 2 - item a3), the surface/ ground water is recharacterized as RCRA F Listed hazardous waste because the "contained in" rule is operable. The applicable EPA waste codes are F001, F002, F003, F005, F006, F007, and F009.

- 5) In accordance with 6 CCR 1007-3 Part 264 196 (e)(3) - Repair of the affected system. The system will be returned to service as soon as the necessary repairs are completed. The following actions will be completed prior to returning the system to operation:

- Repair the primary transfer line,
 - Repair or modify the portion of the secondary containment of the transfer line (the hose connection) within the ITS sump that

failed and resulted in the leak of hazardous waste from the secondary containment system, and

- Retest the primary line following the repair.

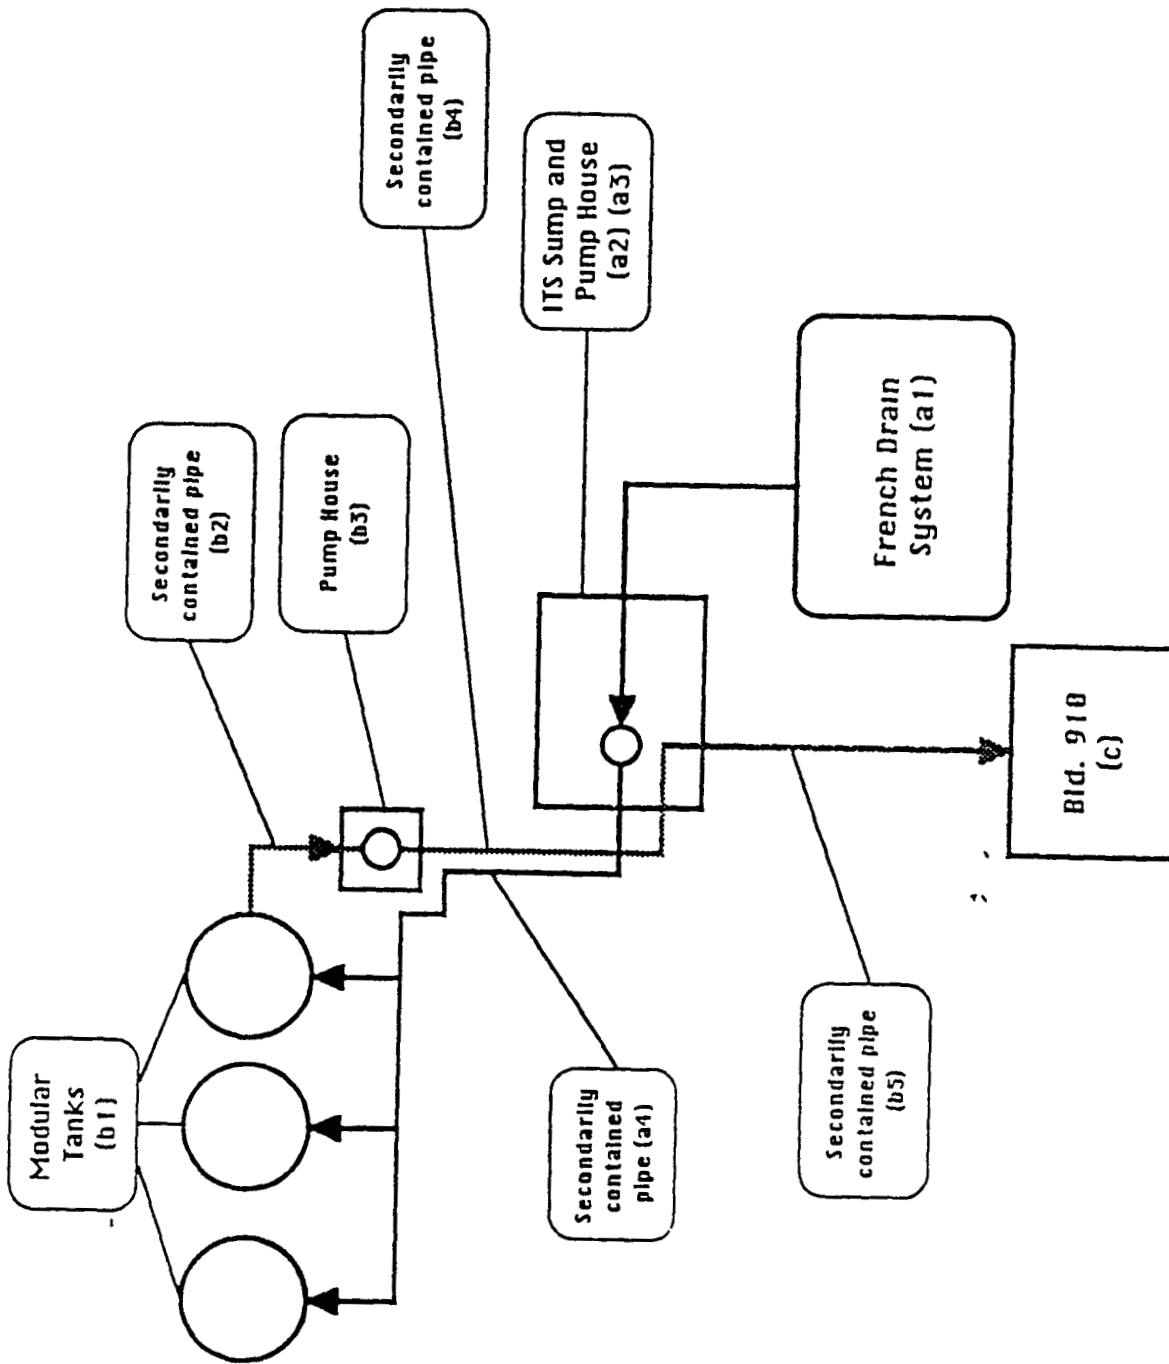
FIGURE 2

- 2) The ITS sump is an underground, unlined, concrete vault that stores the surface and ground water (reference Figure 2 - item a2) The ITS sump is not secondarily contained.
- 3) A small building housing two pumps is located on top of the sump (reference Figure 2 - item a3) The sump pumps transfer the surface and ground water collected in the sump several hundred feet to the modular storage tanks. In accordance with 6 CCR 1007-3, the pumping operation is considered a waste generation point At this point, the generated waste (pumped surface/ ground water) is characterized as RCRA hazardous waste.

- 4) The waste is pumped through 2-inch secondarily contained, buried pipe (reference Figure 2 - items b4 and b5) several hundred feet from the modular tank pumphouse through the ITS sump (reference Figure 2 - item a2) and to the Building 910 treatment system (reference Figure 2 - item c) The primary containment pipe is continuous and does not open to or stop at the ITS sump The secondary containment piping is divided into two sections to allow segregation and identification if a leak should occur The partition between the two section of secondary containment is located within the ITS sump The automatic leak detection system for these two sections of secondary containment was not operational, therefore, daily inspections were being conducted until the automatic system could be made operational The pipeline
